REPORT

SUBJECT: Dwelling – 1 Coral Sea Road
Jerramungup

DATE: 24th October 2011

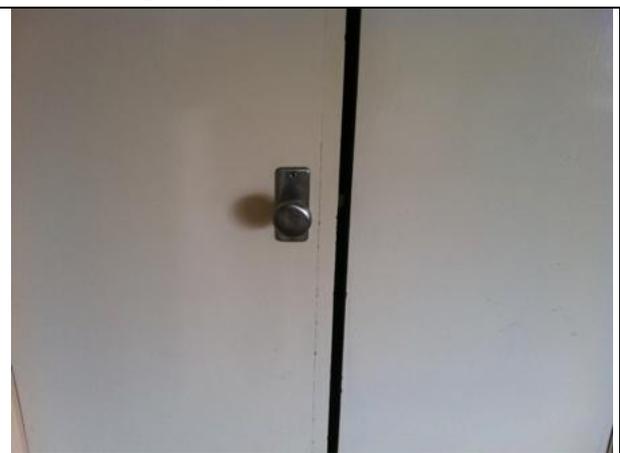
Storage Cupboard Doors

- ✚ Renovate the exhaust hood to the kitchen as it is dangerously low.
- ✚ The doors to the cupboard adjacent to the kitchen do not close properly as they do not come together. New doors, or at least one new door, are required.
- ✚ The tank stand is on a lean and appears to be in a dangerous state. This needs to be secured so that it does not pose a risk.
- ✚ Front verandah is in a dangerous state with lifting floor boards and wood rot post. These need to be replaced. The back verandah post is also affected by severe wood rot and needs replacing.
- ✚ Remove and replace the asbestos fence to the property.
