## **FISHERY BEACH MARINA BOAT RAMP AND JETTY CONSTRUCTION**

## **TECHNICAL SPECIFICATION**

**by Seashore Engineering & Civil Structural Consulting.  
for Shire of Jerramungup**

*SE64-04-R02*

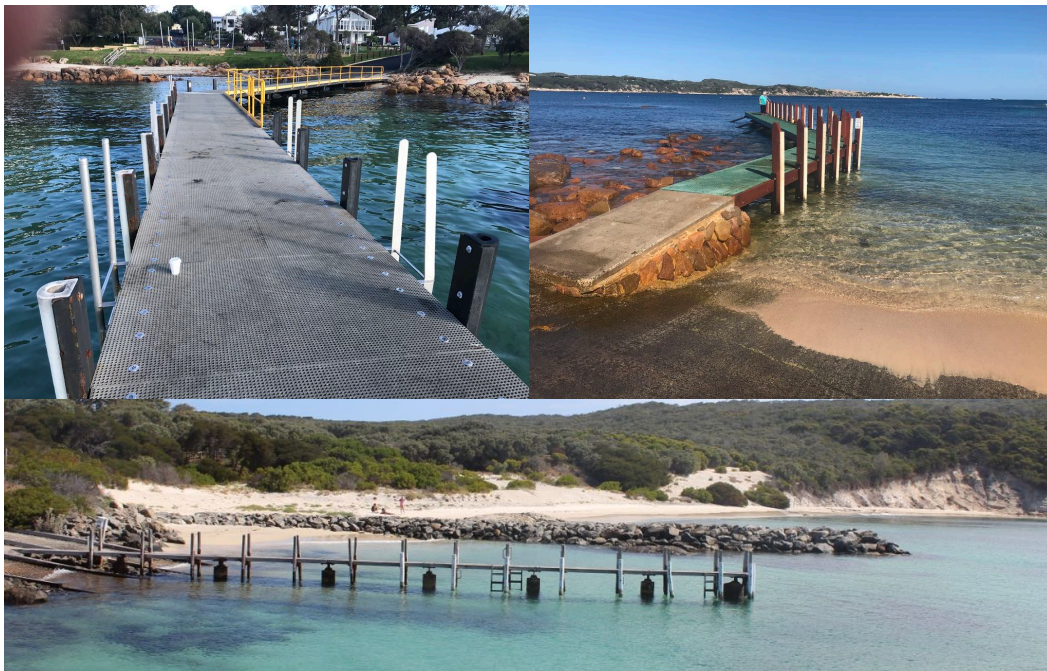
**Figure 1.1 Design Option 1 is based on a 2.0m wide jetty constructed with steel piles (example image Dunsborough, upper left), Design Option 2 requires demolition and replacement of concrete piles from existing jetty at Bremer Bay (lower), whilst Design Option 3 is based on a 1.2m wide jetty on refurbished concrete piles (example image Gracetown, upper right).**

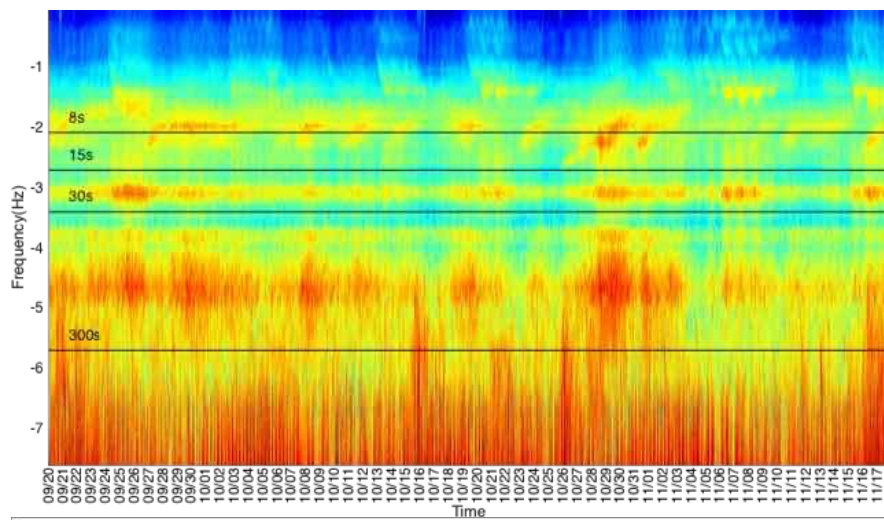
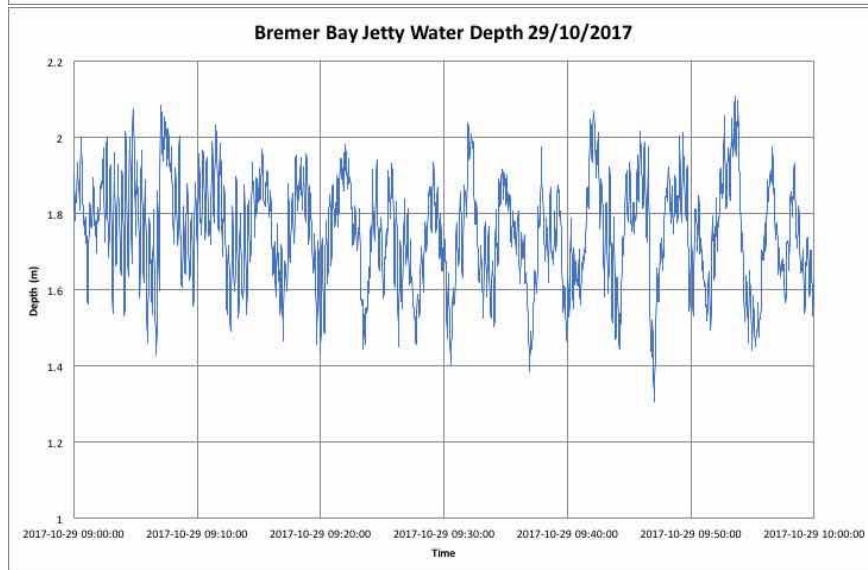
Frequency Bands at Jetty (upper) and water level variations over a 1-hour period at jetty (middle and lower)

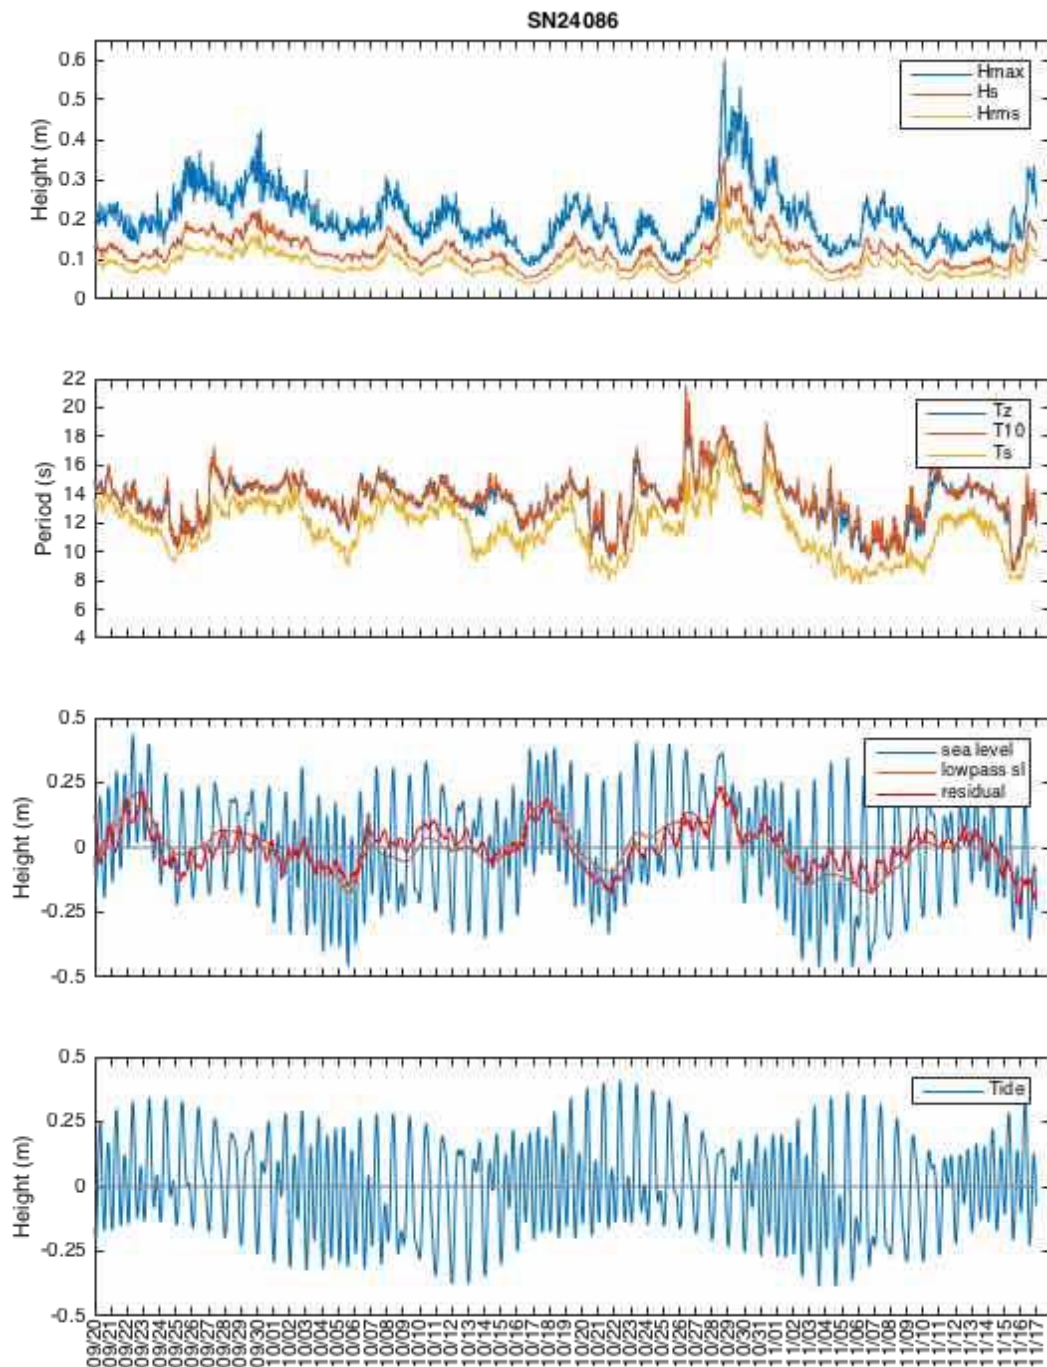
Wave Heights at Wharf

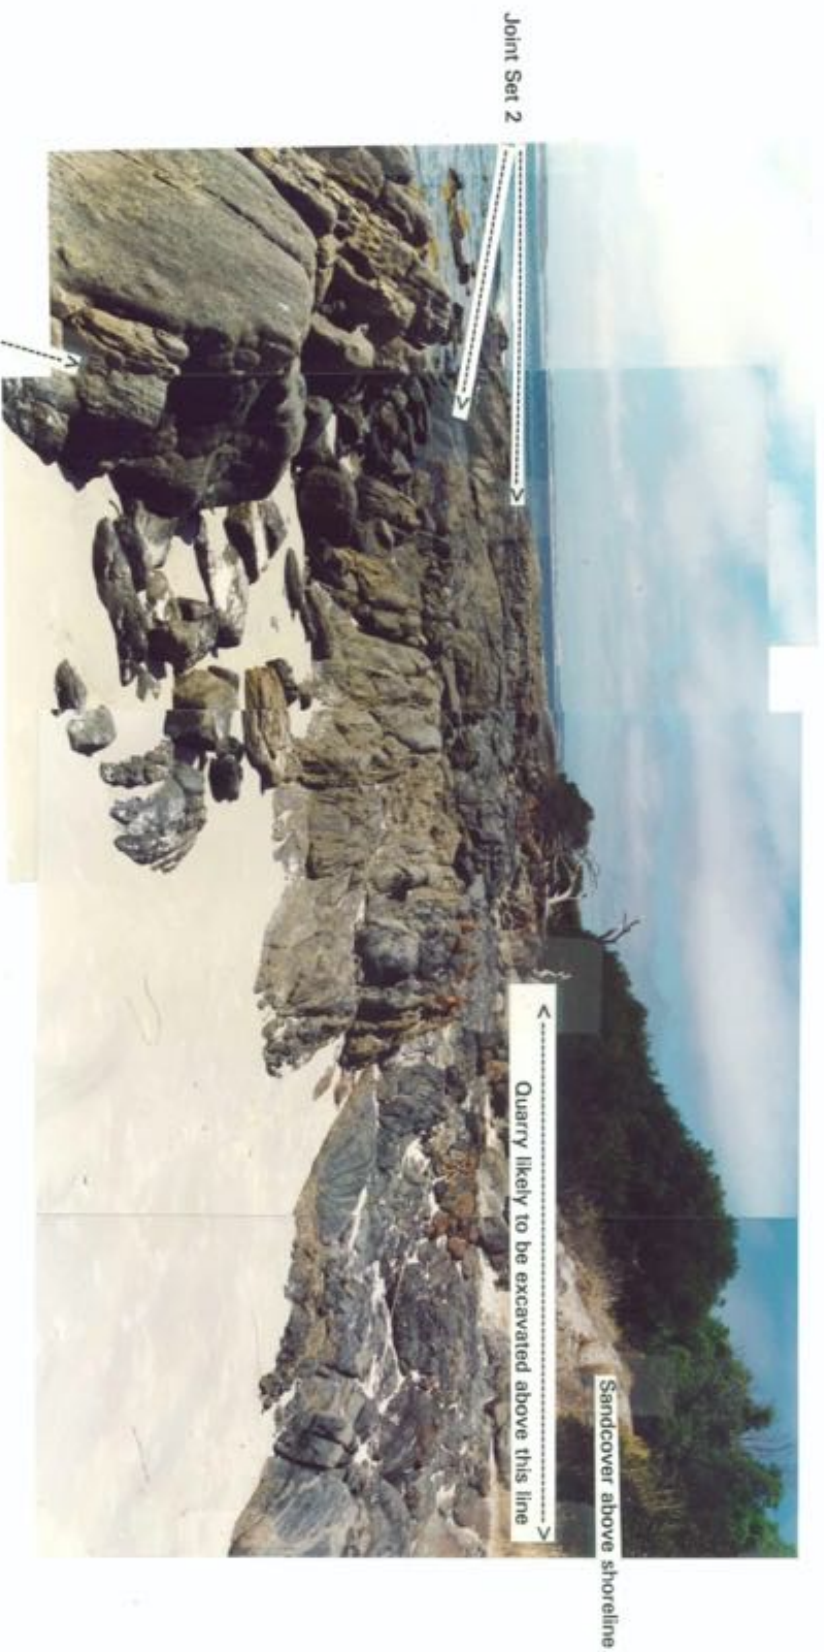
Photographs looking east

Note clustering of Joint Set 2 at proposed boat ramp and also in foreground
