9.3.2 b) FBG Letter Seeking Design Approval for Wellstead Estuary Bird Hide

Title: Wellstead Estuary – Desktop Review of Proposed Bird Hide Site

Project: Wellstead Estuary Bird Hide

SITE CLASSIFICATION REPORT

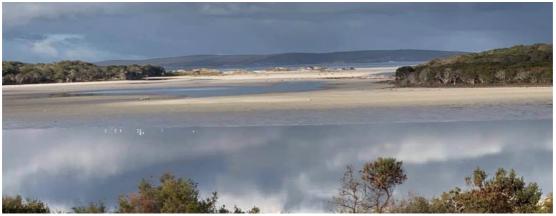
Figure 3 – Tidal Entrance Flood Shoals. Site of Bird Hide is within the bay along the southern shoreline of the lower estuary to right of picture.

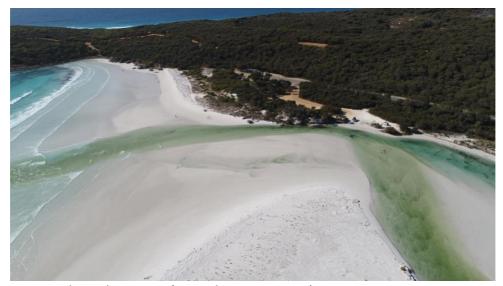
Figure 6 Entrance Channel Jan-2022 (image by Jamie Turner).

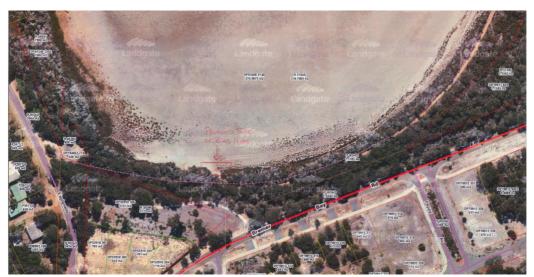
Figure 7 Proposed Bird Hide Site

Site photos have been provided by FBG during lower tides in 2022 appear to show a sandy beach, shallow foreshore grade, marine plants, fringing marshes and organic matter (Figure 7). Additional photos supplied by FBG from June 2023 show the site submerged at higher tides with the entrance open (Figure 8).

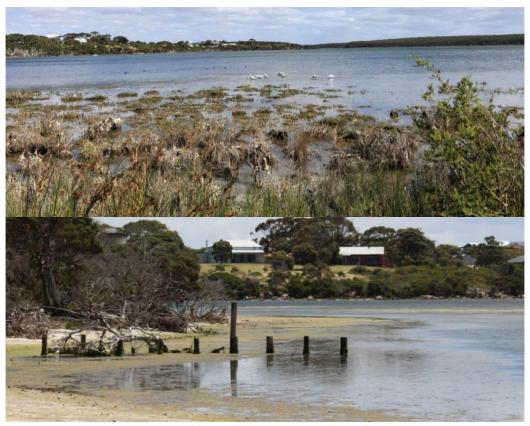
Figure 8 – FBG Site Photos in Jan-2022 (upper) and Dec-2022 (lower) showing what appears to be a sandy beach, marine plants/salt marsh and organic matter.

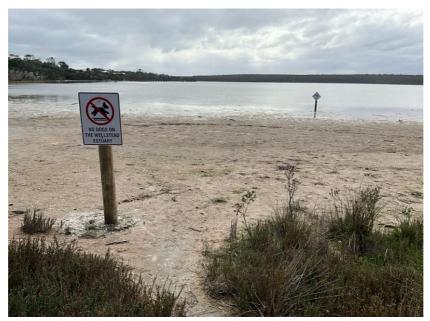
SITE RECORD

BOREHOLE 1: 0 - 600 SAND with artificial deleterious - grey; 600 hard ground refusal.

APPROXIMATE BOREHOLE LOCATIONS

SITE CLASSIFICATION S (in accordance with AS2870)
