BAL Assessment and Advice Report

Lot 152 Point Henry Road

FINAL

23/06/2023

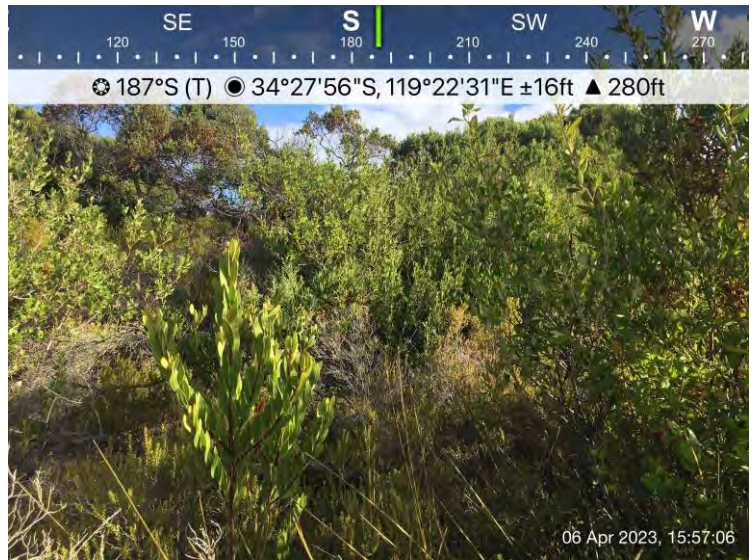
Photo ID:	1	Plot:	1
Vegetation Classification or Exclusion Clause			
Excludable - 2.2.3.2(a) >100m from site			
Description / Justification for Classification			
Location: Southeast and east of the subject site. Separation Distance: 110m to the southeast, 141m to the east. Description: Areas of classified vegetation >100m from the subject site. Excluded as per AS3959 exclusion clause 2.2.3.2 (a). Photo description: View to the south towards classifiable vegetation, located greater than 100m from the subject site to the east-southeast.			
Photo ID:	2	Plot:	1 cont.
Vegetation Classification or Exclusion Clause			
Excludable - 2.2.3.2(a) >100m from site			
Description / Justification for Classification			
Additional Photo of Plot 1. Photo description: View to the south-southeast towards classifiable vegetation, located greater than 100m from the subject site to the southeast.

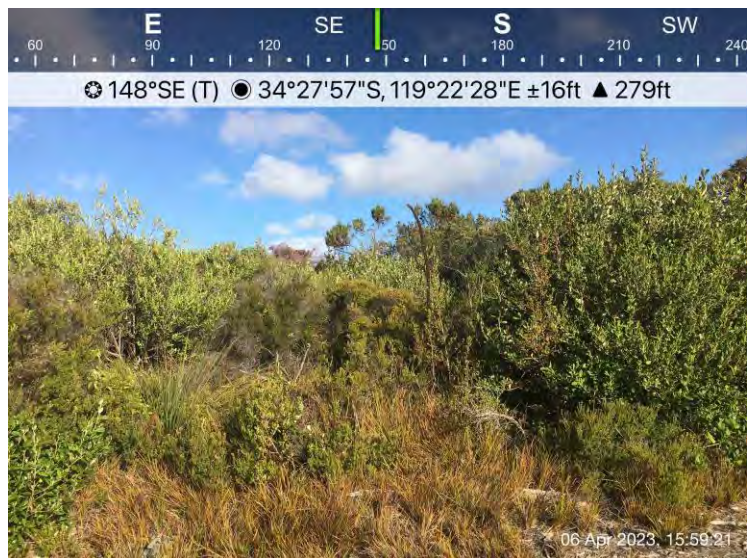
Photo ID:	3	Plot:	1 cont.
Vegetation Classification or Exclusion Clause			
Excludable - 2.2.3.2(a) >100m from site			
Description / Justification for Classification			
Additional Photo of Plot 1.			
Photo description: View to the southeast towards classifiable vegetation, located greater than 100m from the subject site to the east.			
Photo ID:	4	Plot:	2
Vegetation Classification or Exclusion Clause			
Excludable - 2.2.3.2(f) Low Threat Vegetation			
Description / Justification for Classification			
Location: North, northwest, east, southeast, and internal to the subject site.			
Description: Vegetation managed in a low threat state including slashed breaks.			
As per exclusion clause 2.2.3.2 (f) of AS3959-2018.			
Photo description: View to the south-southeast along a strategic break, located to the east of the subject site.			
Photo ID:	5	Plot:	2 cont.
Vegetation Classification or Exclusion Clause			
Excludable - 2.2.3.2(f) Low Threat Vegetation

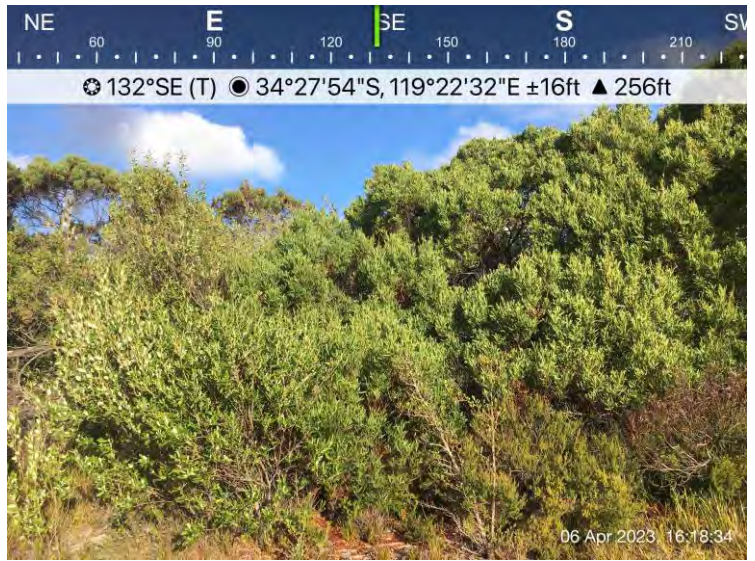
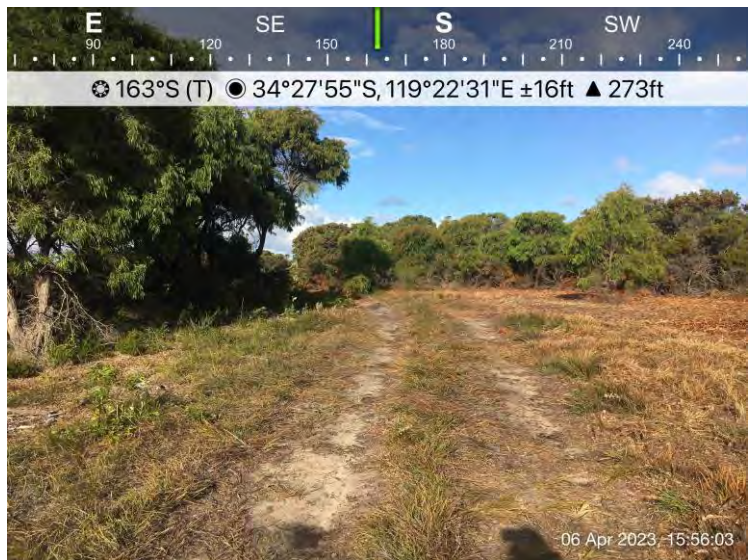
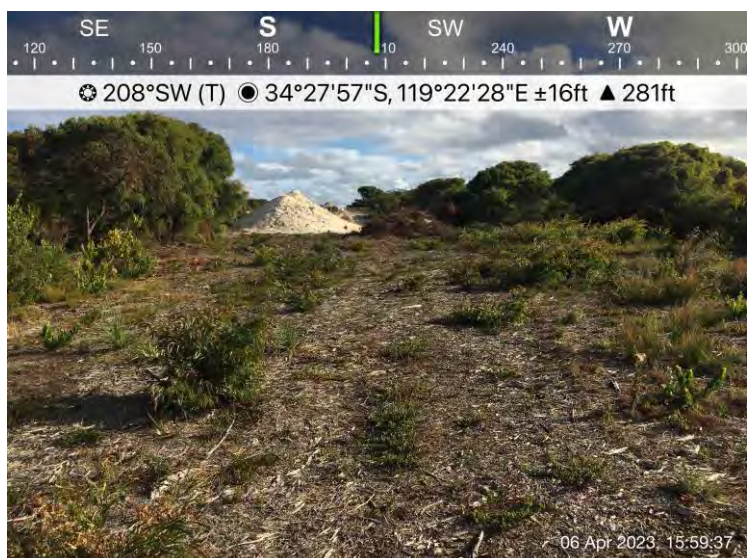
Description / Justification for Classification			
Additional Photo of Plot 2.			
Photo description: View facing south-southwest along the strategic break, located to the southeast of the subject site.

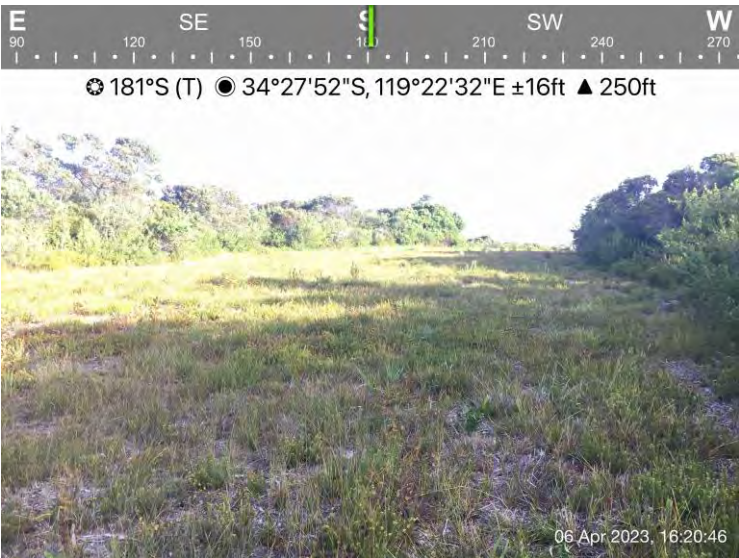
Photo ID:	8	Plot:	2 cont.
Vegetation Classification or Exclusion Clause			
Excludable - 2.2.3.2(f) Low Threat Vegetation			
Description / Justification for Classification			
Additional Photo of Plot 2. Photo description: View to the northwest along the strategic break, located internally to the subject site.

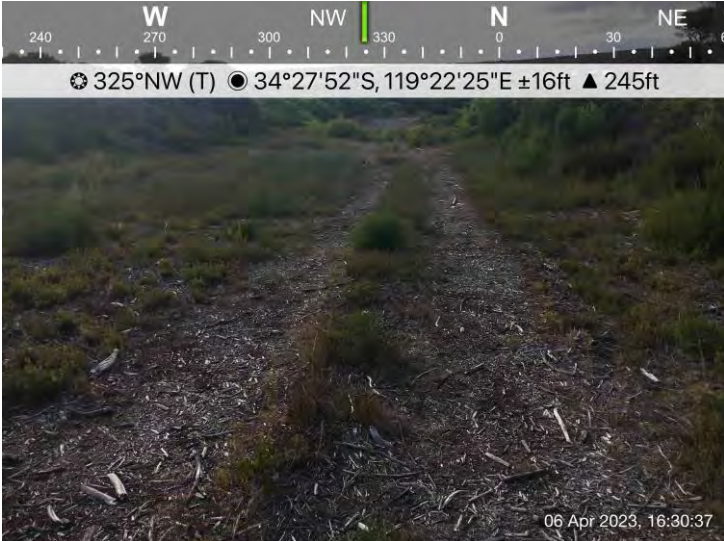
Photo ID:	9	Plot:	3
Vegetation Classification or Exclusion Clause			
Class D Scrub - Closed scrub (Tall heaths) D-13			
Description / Justification for Classification			
Location: Internal to the subject site in the northwest, west, southwest, south, southeast and east. External to the south, southeast and east. Separation Distance: 0m. Description: Coastal Scrub consisting of low Peppermint trees, Acacias, Spyridium, Leucopogon, Adenanthos, Hibbertia, grasses and sedges. Average vegetation height: <4m. Occasional peppermint tree up to 6m due to edge effect. Vegetation Coverage: 10-30% foliage cover. Available fuel loading: 25t/ha. Effective slope: Upslope/flat. Photo description: View to the east-northeast towards scrub vegetation, located to the east of the subject site.

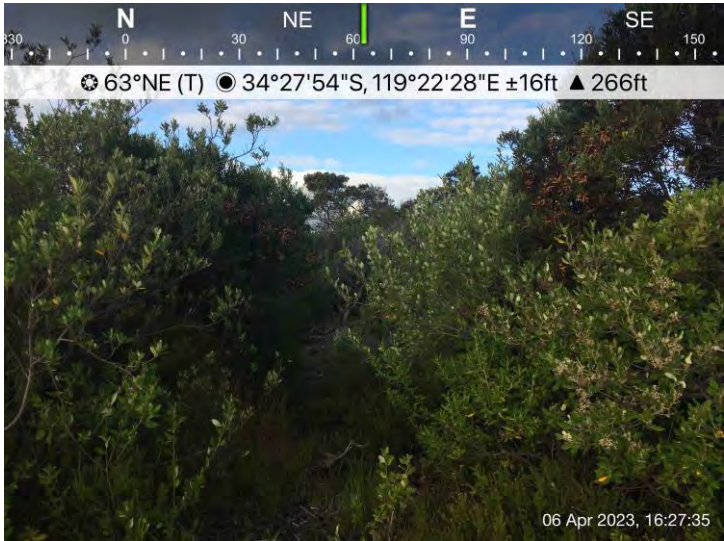
Photo ID:	10	Plot:	3 cont.
Vegetation Classification or Exclusion Clause			
Class D Scrub - Closed scrub (Tall heaths) D-13			
Description / Justification for Classification			
Additional Photo of Plot 3.			
Photo description: View to the east towards scrub vegetation, located to the east of the subject site.

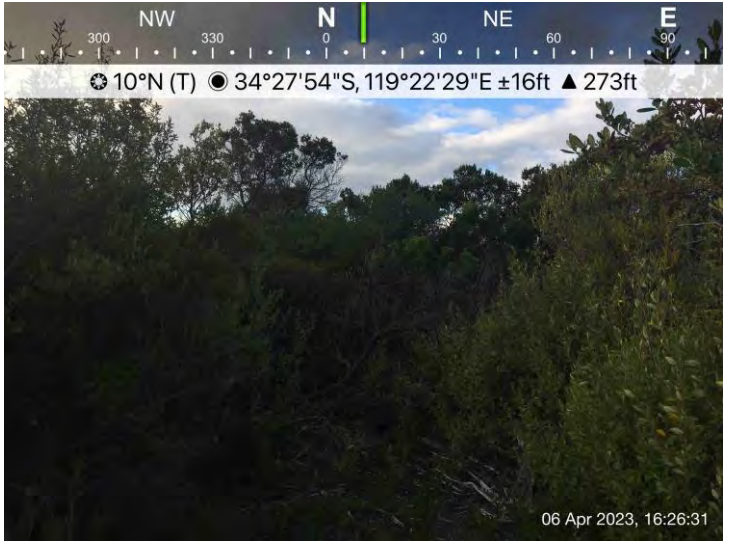
Photo ID:	14	Plot:	3 cont.
Vegetation Classification or Exclusion Clause			
Class D Scrub - Closed scrub (Tall heaths) D-13			
Description / Justification for Classification			
Additional Photo of Plot 3. Photo description: View to the northeast towards scrub vegetation, located to the south of the subject site.

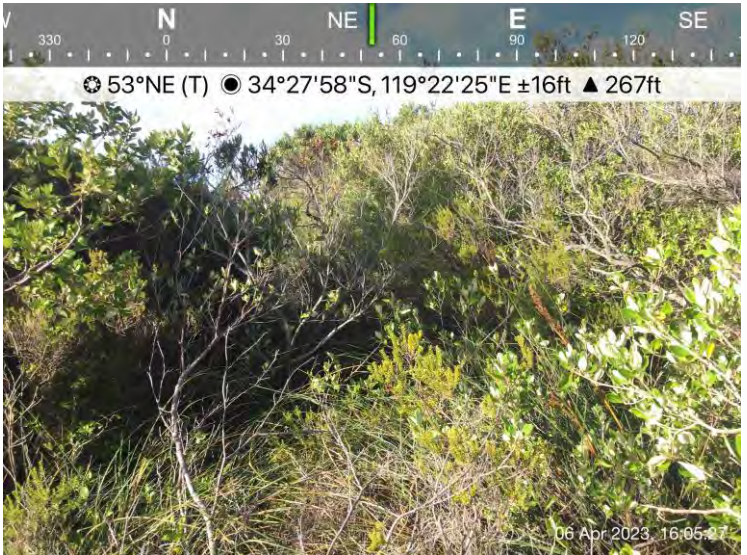
Photo ID:	15	Plot:	4
Vegetation Classification or Exclusion Clause			
Class D Scrub - Closed scrub (Tall heaths) D-13			
Description / Justification for Classification			
Location: West, southwest, north, and northeast of the subject site. Separation Distance: 0m to the west. Description: Coastal Scrub consisting of low Peppermint trees, acacias, Acacias, Spyridium, Leucopogon, Adenanthos, Hibbertia, grasses and sedges. Average vegetation height: <4m. Occasional peppermint tree up to 6m due to edge effect. Vegetation Coverage: 10-30% foliage cover. Available fuel loading: 25t/ha. Effective slope: Downslope >0 to 5 degrees. Photo description: View facing east towards scrub vegetation, located to the southwest of the subject site.			
Photo ID:	16	Plot:	4 cont.
Vegetation Classification or Exclusion Clause			
Class D Scrub - Closed scrub (Tall heaths) D-13			
Description / Justification for Classification

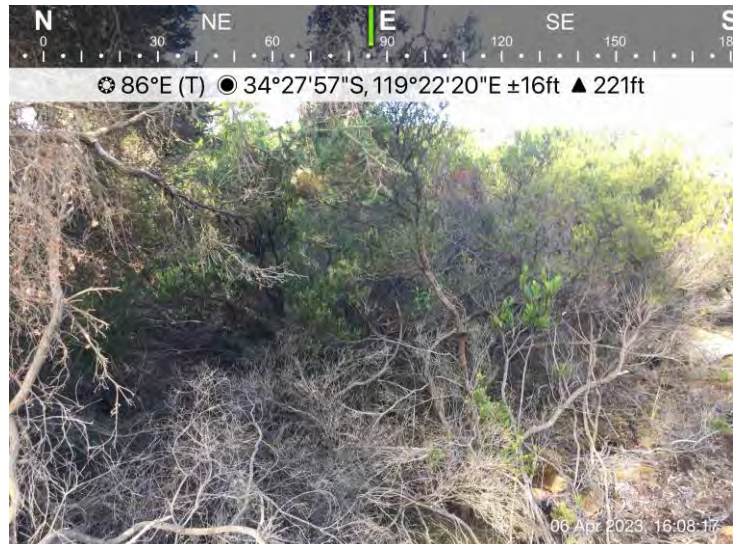
Additional Photo of Plot 4. Photo description: View facing northeast towards scrub vegetation, located to the northwest of the subject site.

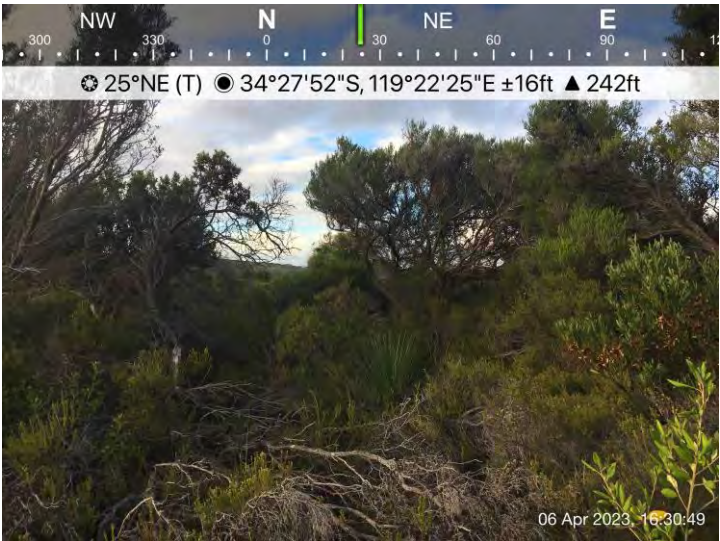
Photo ID:	17	Plot:	4 cont.
Vegetation Classification or Exclusion Clause			
Class D Scrub - Closed scrub (Tall heaths) D-13			
Description / Justification for Classification			
Additional Photo of Plot 4.			
Photo description: View facing north-northeast towards scrub vegetation, located to the north of the subject site.

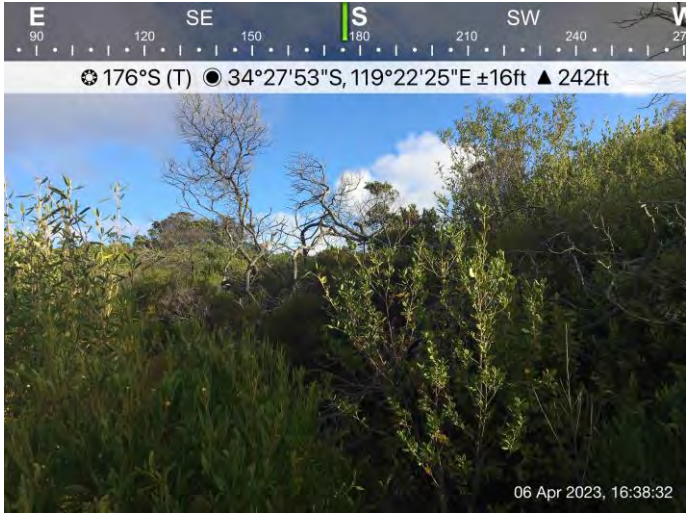
Photo ID:	18	Plot:	4 cont.
Vegetation Classification or Exclusion Clause			
Class D Scrub - Closed scrub (Tall heaths) D-13			
Description / Justification for Classification			
Additional Photo of Plot 4.			
Photo description: View facing south towards scrub vegetation, located to the west of the subject site.

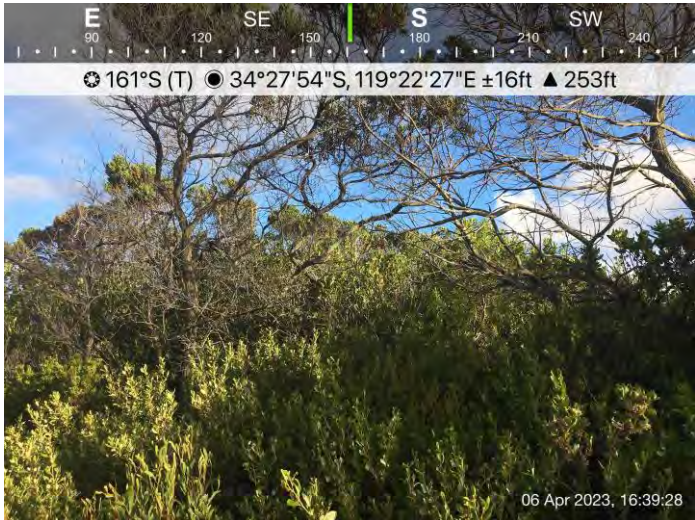
Photo ID:	19	Plot:	4 cont.
Vegetation Classification or Exclusion Clause			
Class D Scrub - Closed scrub (Tall heaths) D-13			
Description / Justification for Classification			
Additional Photo of Plot 4.			
Photo description: View facing south-southeast towards scrub vegetation, located to the northeast of the subject site.

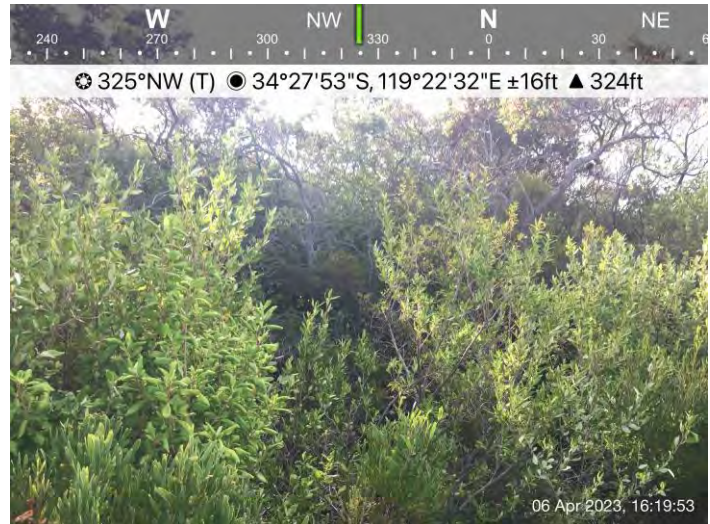
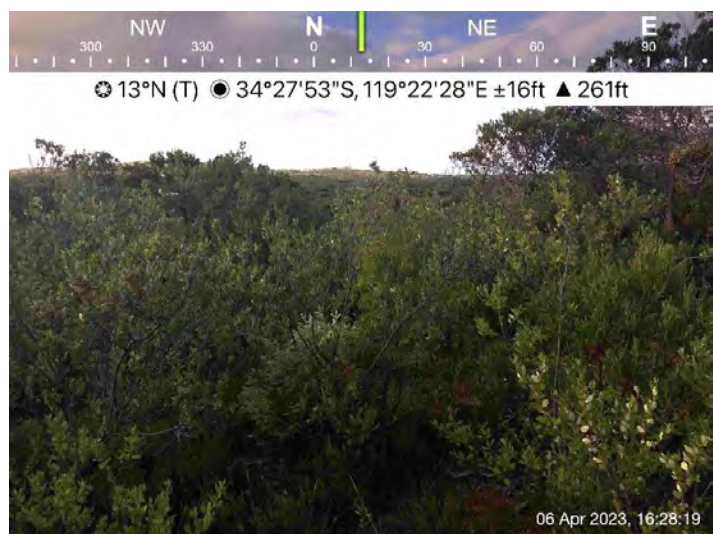
Photo ID:	20	Plot:	5
Vegetation Classification or Exclusion Clause			
Class D Scrub - Closed scrub (Tall heaths) D-13			
Description / Justification for Classification			
<p>Location: East, north, northeast, and northwest of the subject site.</p> <p>Separation Distance: 1m.</p> <p>Description: Coastal Scrub consisting of low Peppermint trees, Acacias, Spyridium, Leucopogon, Adenanthos, Hibbertia, grasses and sedges.</p> <p>Average vegetation height: <4m. Occasional peppermint tree up to 6m due to edge effect.</p> <p>Vegetation Coverage: 10-30% foliage cover.</p> <p>Available fuel loading: 25t/ha.</p> <p>Effective slope: Downslope >5 to 10 degrees</p> <p>Photo description: View facing northwest towards scrub vegetation, located to the east of the subject site.</p>			
Photo ID:	21	Plot:	5 cont.
Vegetation Classification or Exclusion Clause			
Class D Scrub - Closed scrub (Tall heaths) D-13			
Description / Justification for Classification

<p>Additional Photo of Plot 5.</p> <p>Photo description: View facing north-northeast towards scrub vegetation, located to the east of the subject site.</p>

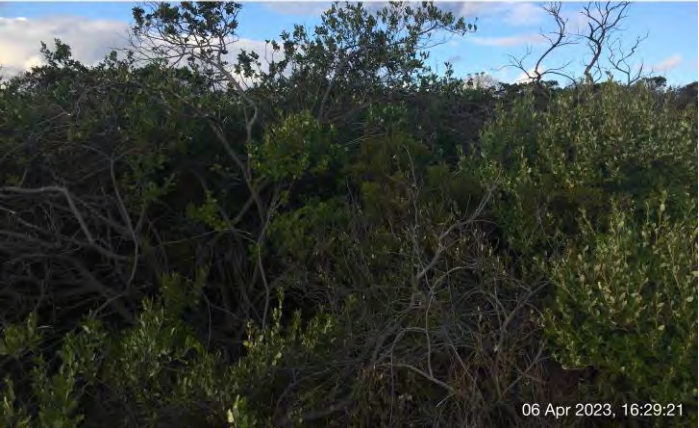
<p>06 Apr 2023, 16:29:21</p>
Vegetation Classification or Exclusion Clause		
Class D Scrub - Closed scrub (Tall heaths) D-13		
Description / Justification for Classification		
Additional Photo of Plot 5.		
Photo description: View facing east-northeast towards scrub vegetation, located to the northwest of the subject site.		
Photo ID: 23	Plot: 5 cont.

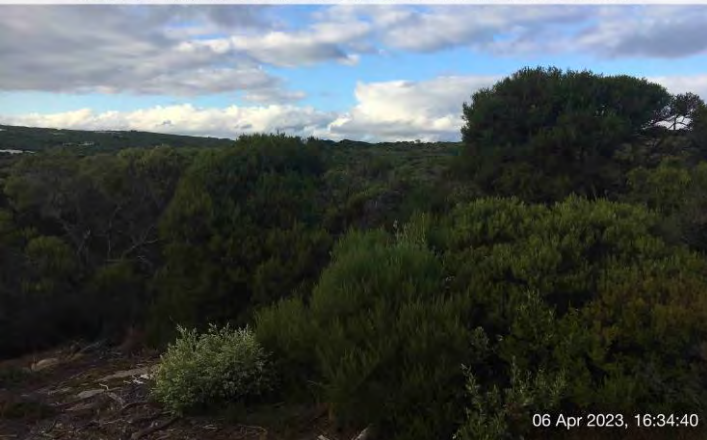
<p>06 Apr 2023, 16:34:40</p>
Vegetation Classification or Exclusion Clause		
Class D Scrub - Closed scrub (Tall heaths) D-13		
Description / Justification for Classification		
Additional Photo of Plot 5.		
Photo description: View facing north-northeast towards scrub vegetation, located to the north of the subject site.		
Photo ID: 24	Plot: 5 cont.

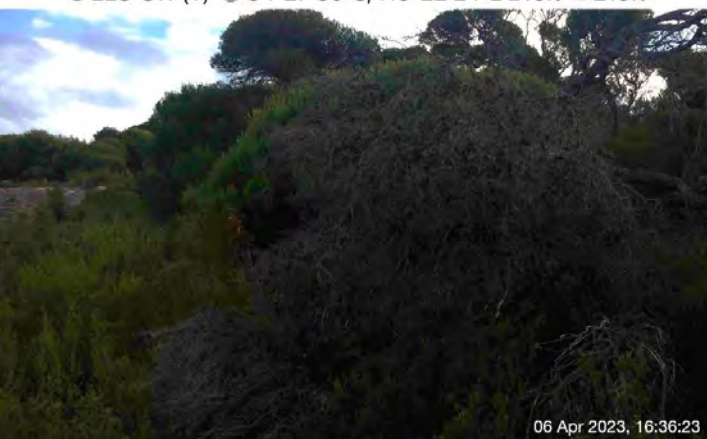
Vegetation Classification or Exclusion Clause		
Class D Scrub - Closed scrub (Tall heaths) D-13		
Description / Justification for Classification		
Additional Photo of Plot 5.		
Photo description: View facing southwest towards scrub vegetation, located to the north of the subject site.

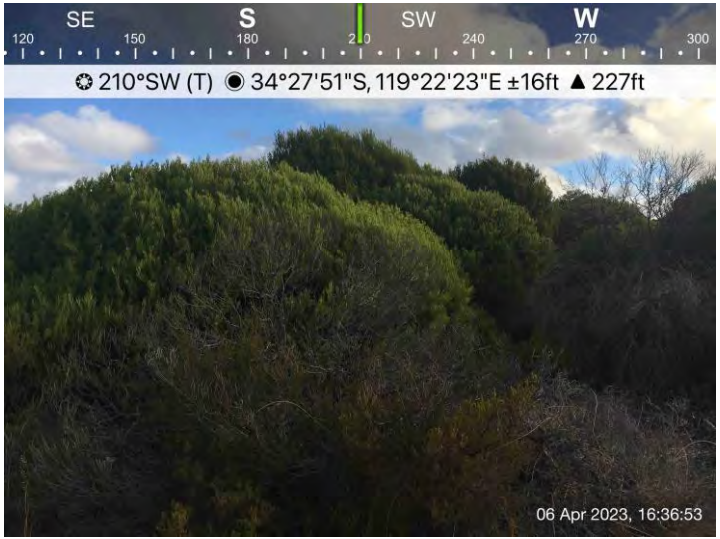
Photo ID:	25	Plot:	5 cont.
Vegetation Classification or Exclusion Clause			
Class D Scrub - Closed scrub (Tall heaths) D-13			
Description / Justification for Classification			
Additional Photo of Plot 5.			
Photo description: View facing south-southwest towards scrub vegetation, located to the north-northwest of the subject site.

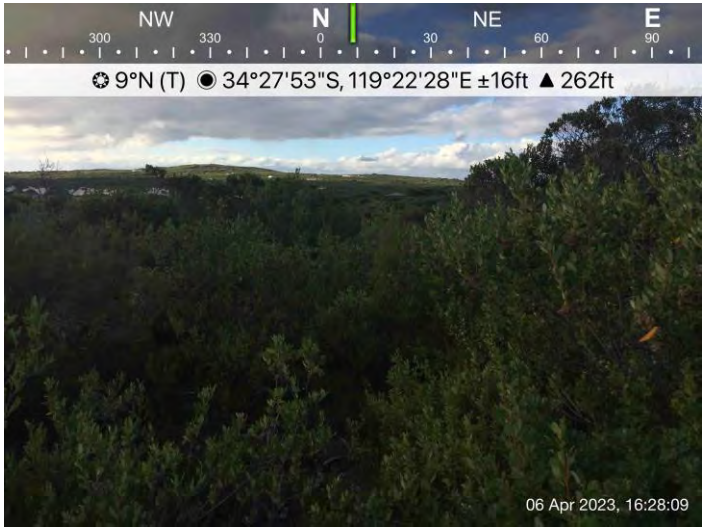
Photo ID:	26	Plot:	5 cont.
Vegetation Classification or Exclusion Clause			
Class D Scrub - Closed scrub (Tall heaths) D-13			
Description / Justification for Classification			
Additional Photo of Plot 5.			
Photo description: View facing north towards scrub vegetation, located to the east of the subject site.
