SHIRE OF JERRAMUNGUP
FORMER BREMER BAY TELEGRAPH STATION
HERITAGE ADVICE
6 OCTOBER 2015

Planning Application (29 September 2015) received for the adaptation of the former Bremer Bay Telegraph Station to a restaurant.

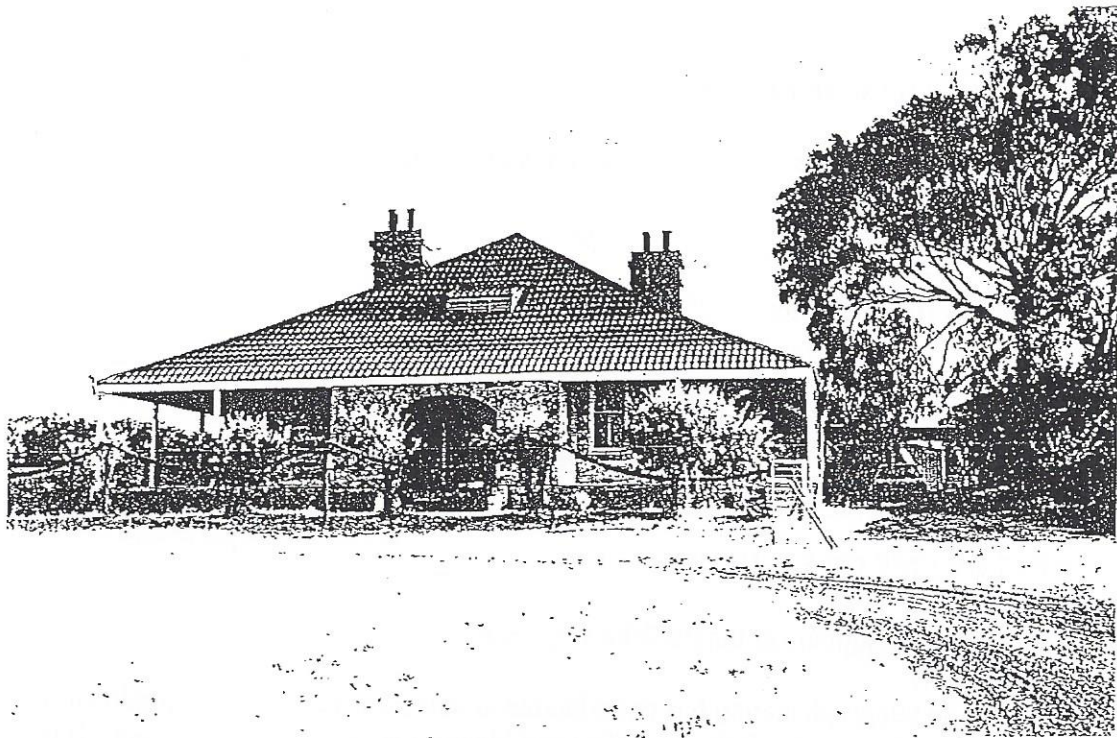
Construction materials:	Brick and Iron (now tile)
Modifications:	Nil
Extent of original fabric:	90%
General Condition:	Good
Description:	Single storey residence:

The telegraph station has considerable architecture and historical significance. Its style is particularly Australian and blends well with the environment. It is built of local stone in a random rubble wall and originally covered in corrugated iron and has verandahs on all sides. It has an interesting entrance and ballustrading. Also it was one of the stations that linked the west coast with the south and is important for the early history of the area.
