Site Survey Sand Pit Two  
 At Lot 201 (#11298)  
 Borden-Bremer Bay Road,  
 Bremer Bay 20-06-2022

2022-77-02A

**Site Survey - Sand Pit One**  
At Lot 1213 Borden-Bremer Bay Road,  
Bremer Bay

Drawing No.  
**2022-77-01A**

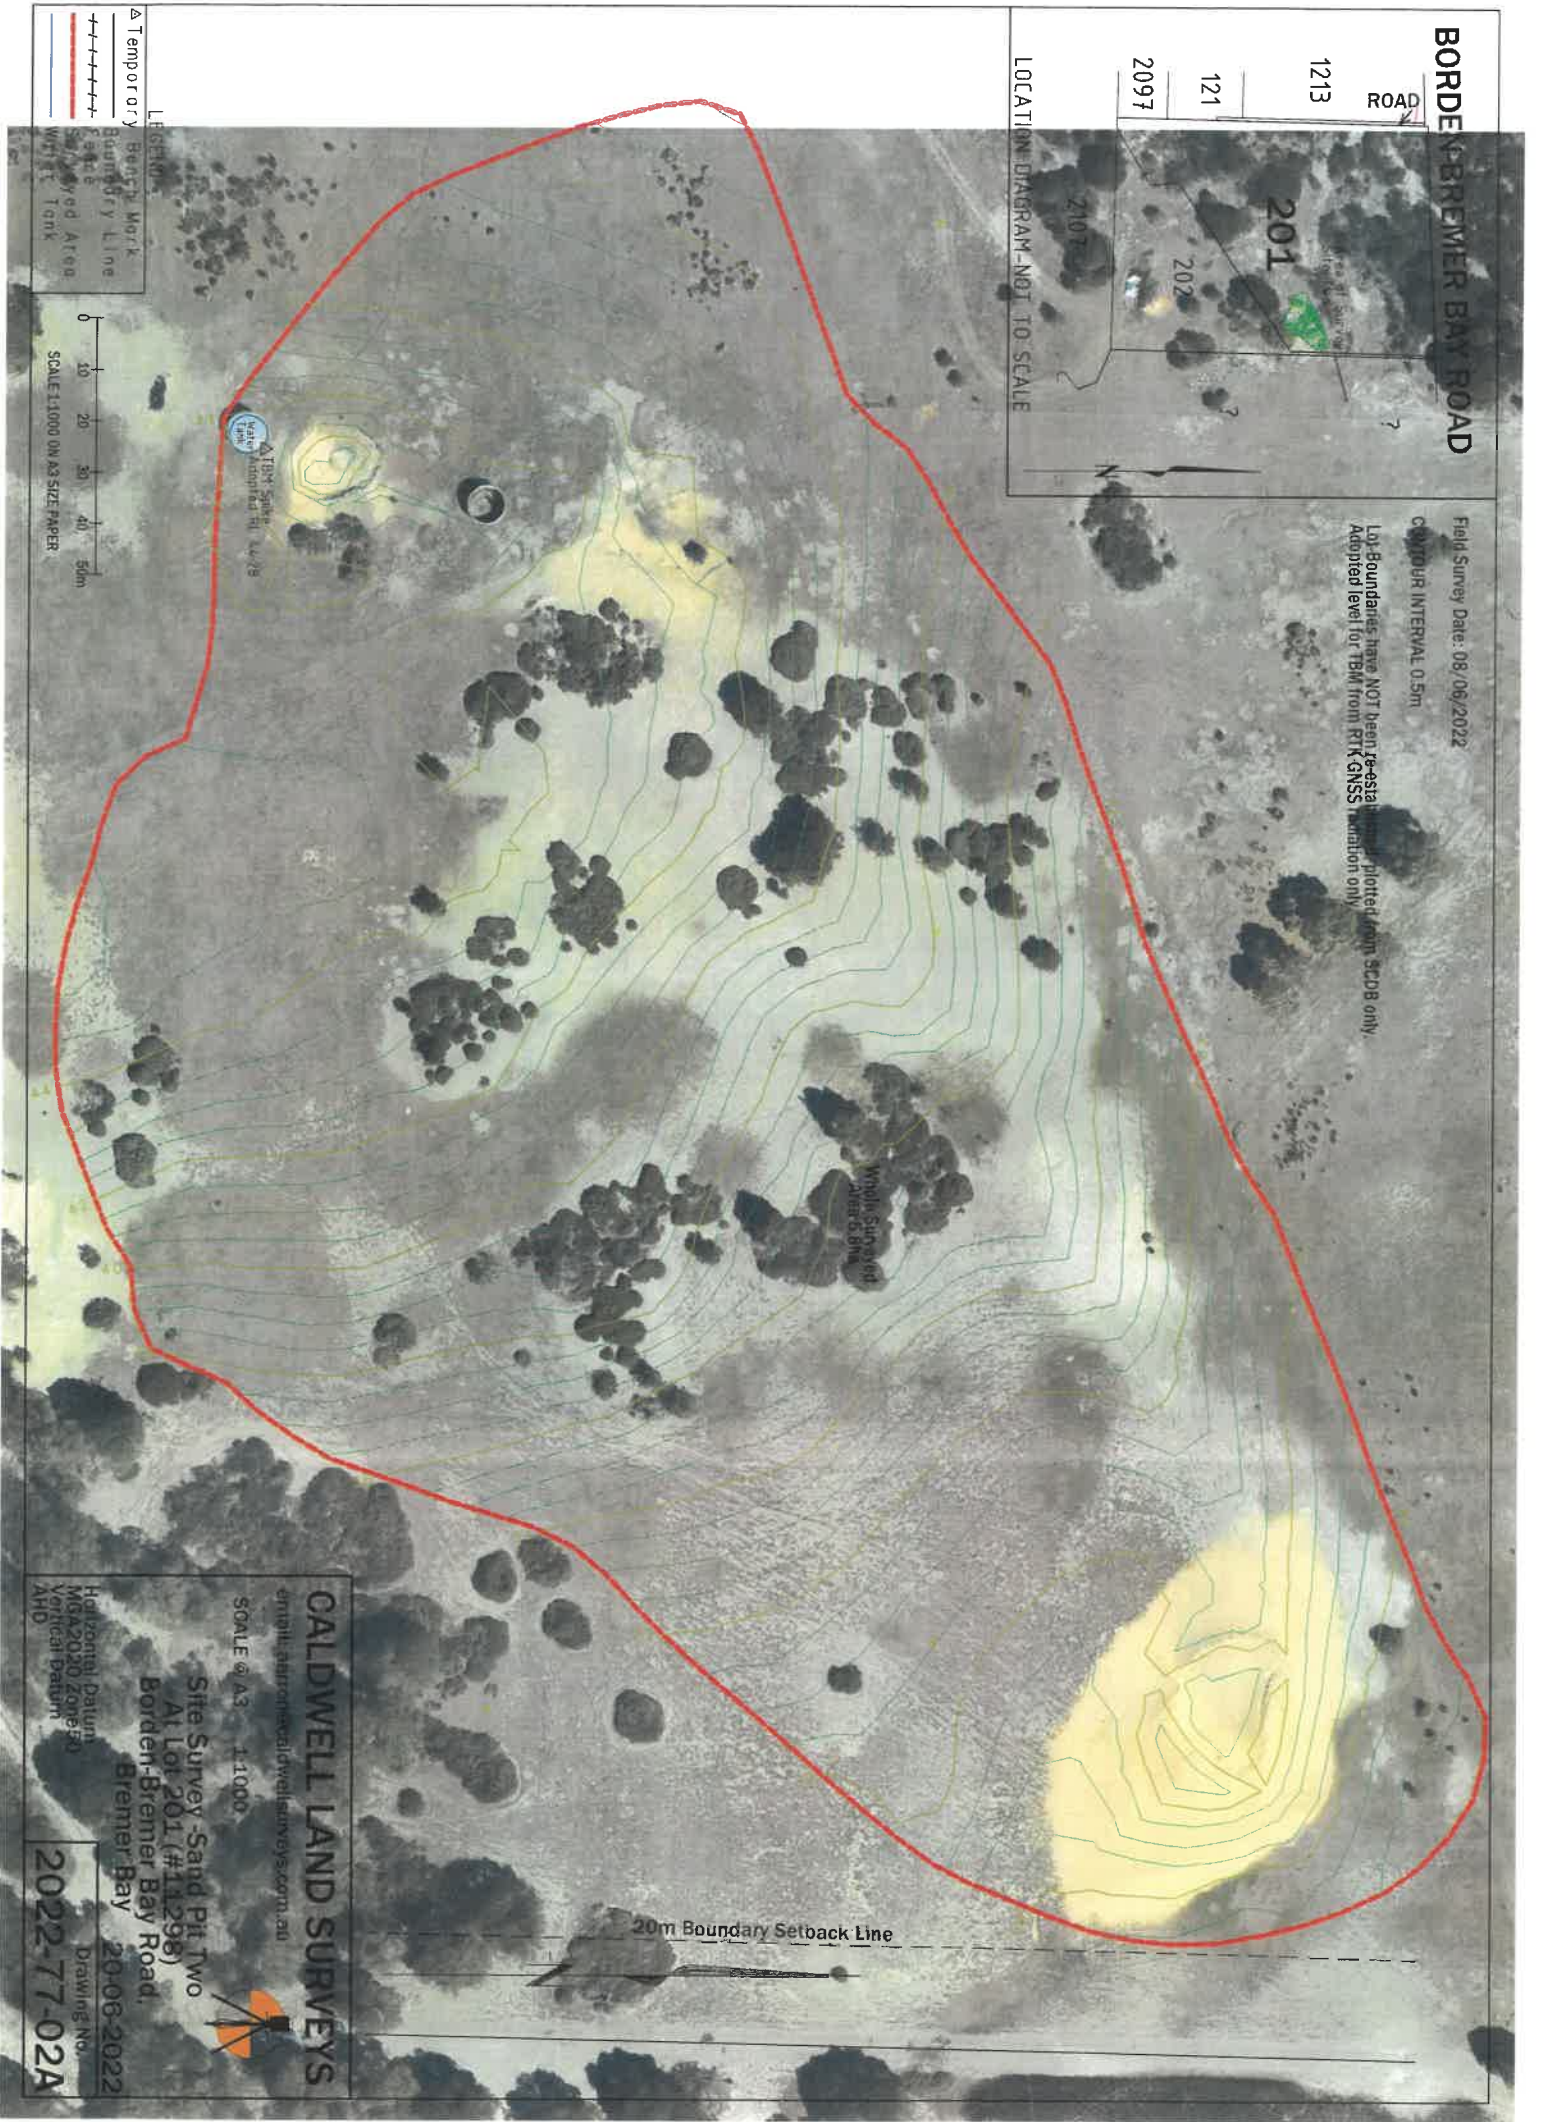
CONTOUR INTERVAL 0.5m

Lot Boundaries have NOT been re-established, plotted from SCDB only. Adopted level for B.M. from RTK GNSS, radiation only.

▲ B.M. spot  
 (level adopted to 44.78)

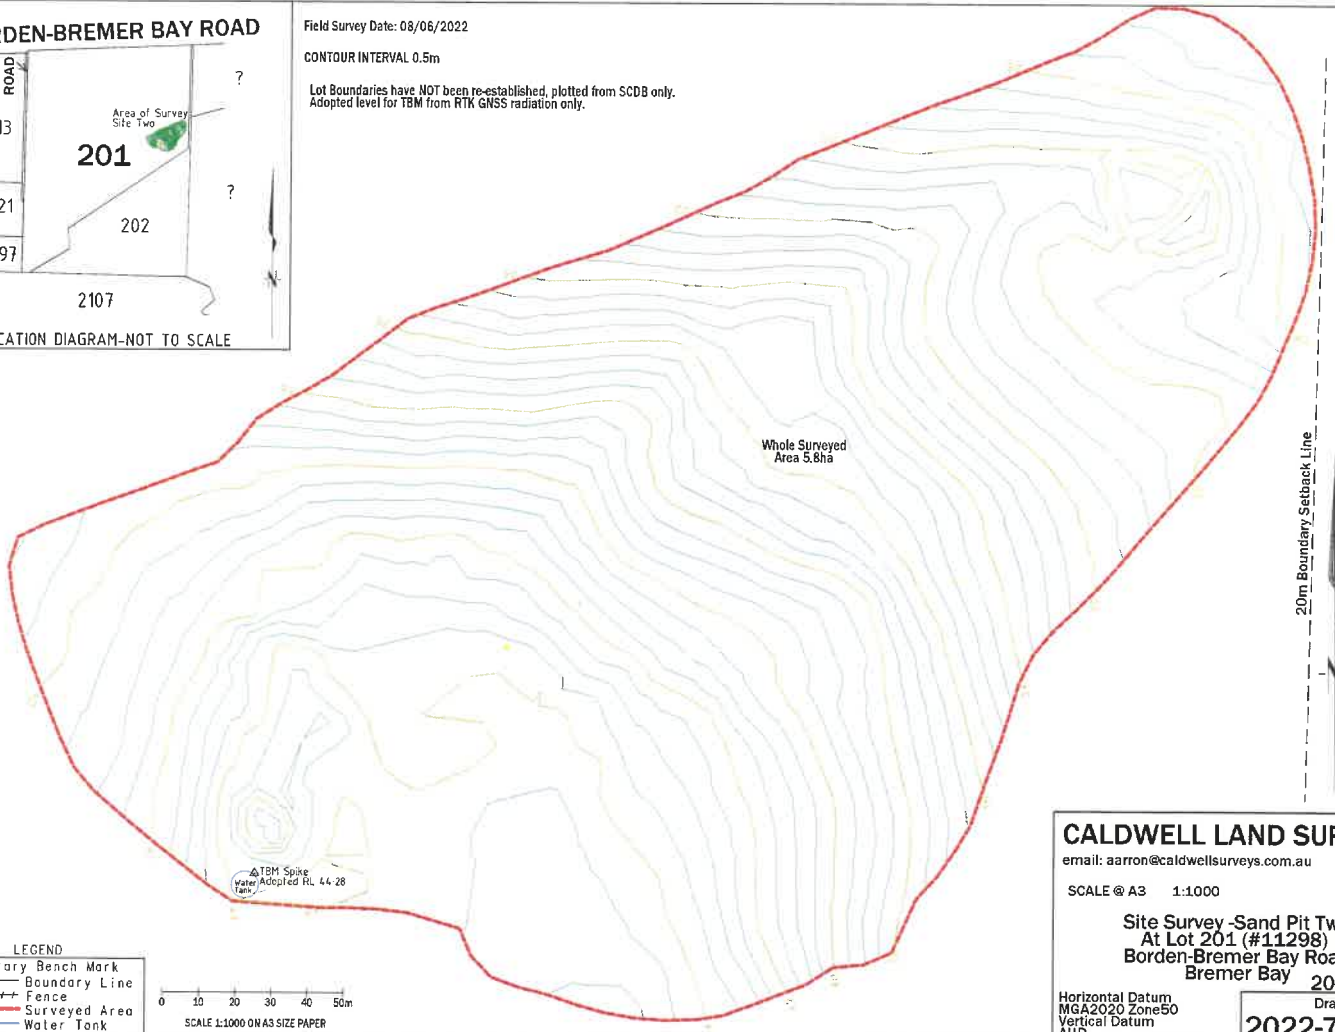
Drawing No.  
**2022-77-02A**

CONTOUR INTERVAL 0.5m

Lot Boundaries have NOT been re-established, plotted from SCDB only. Adopted level for TBM from RTK GNSS radiation only.

△ TBM Spike  
Water Adopted RL 44.28

Site Survey - Sand Pit Two  
At Lot 201 (#11298)  
Borden-Bremer Bay Road,  
Bremer Bay

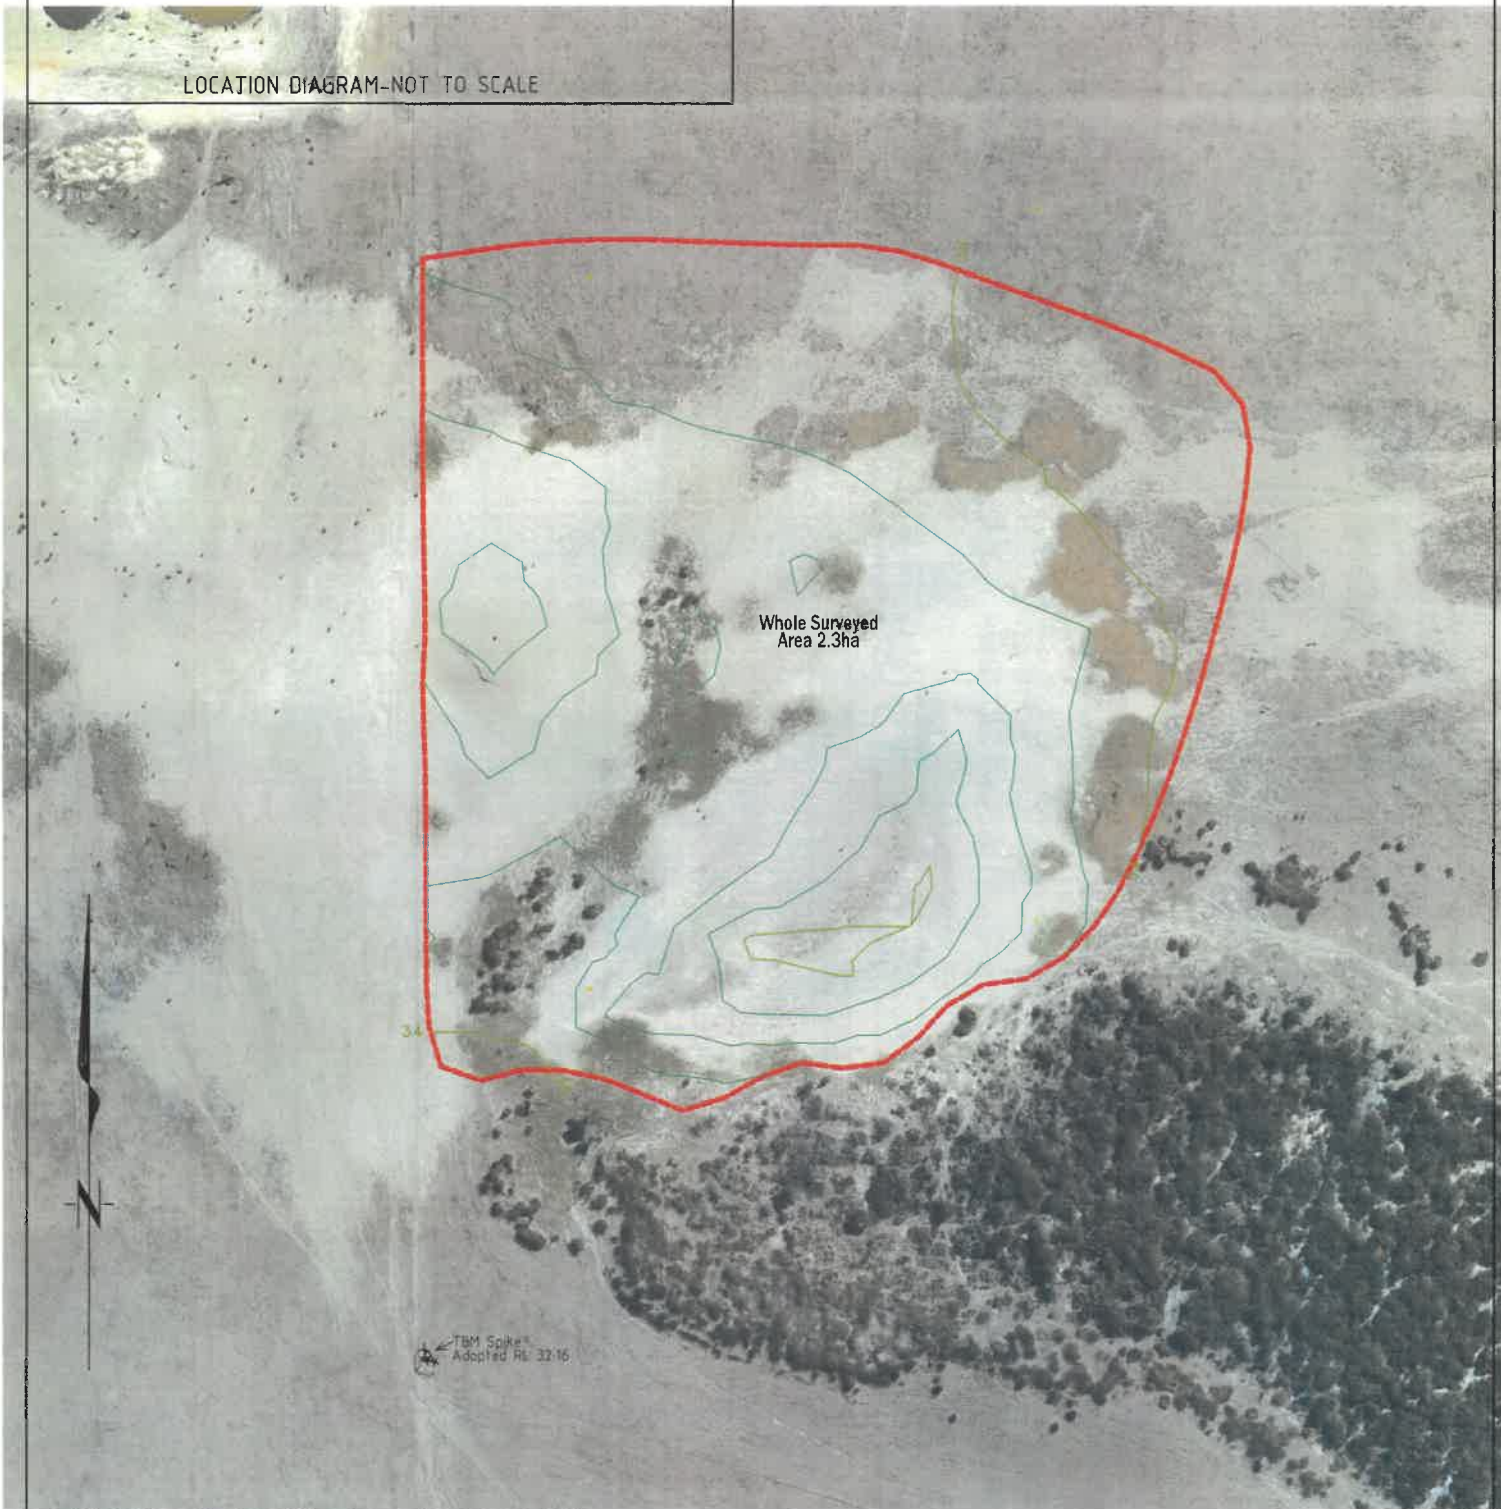
Lot Boundaries have NOT been re-established, plotted from SCDB only.  
Adopted level for TBM from RTK GNSS radiation only.

CONTOUR INTERVAL 0.5m
